# Manhole Inspection Summary

Manhole # S51I\_\_022MH

Insp Date: **4/2/08 1:37 PM**

**Location** Address: **500 Eastern Av**

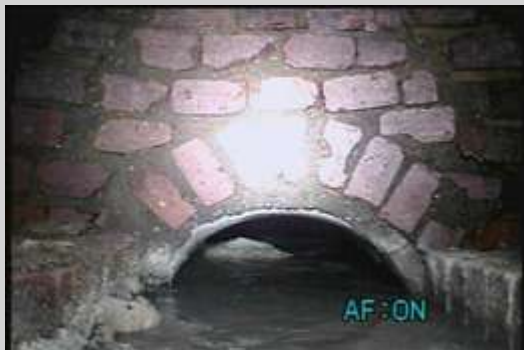
12 O'Clock Outflow

15 in. Circular Gravity Sewer  
Pipe Out @ 12 O'Clock

Pipe Material: **Clay** ☐ Pipe Lined

Invert Depth: **9.38** (ft.) Flow Characteristics: **Fast**

Deposits: ☒ None ☐ Mud ☐ Sludge ☐ Debris ☐ Grease

Infiltration: **None** Pipe Seal Cond: **Unknown**

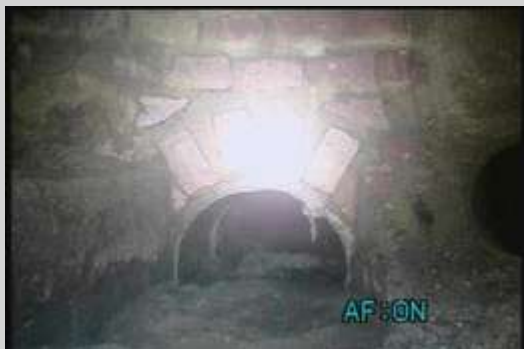
7 O'Clock Inflow

12 in. Circular Gravity Sewer  
Pipe In @ 7 O'Clock

Pipe Material: **Clay** ☐ Pipe Lined

Invert Depth: **9.30** (ft.) Flow Characteristics: **Fast**

Deposits: ☒ None ☐ Mud ☐ Sludge ☐ Debris ☐ Grease

Infiltration: **None** Pipe Seal Cond: **Unknown**

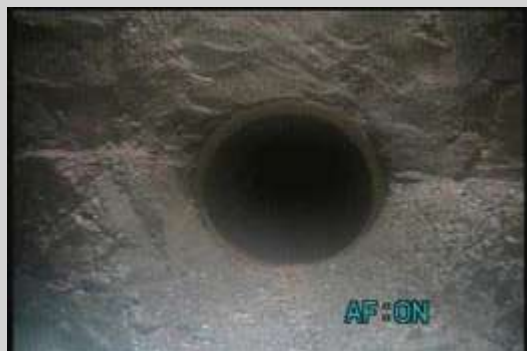
8 O'Clock Inflow

6 in. Circular Gravity Sewer  
Pipe In @ 8 O'Clock

Pipe Material: **Clay** ☐ Pipe Lined

Infiltration: **None** Pipe Seal Cond: **Unknown**
